## TRUCK ROUTE ACCESS EVALUATION

Campbell-Hausfeld  
Leitchfield-Grayson County  
Site # 2637

Report No. KTC-99-47

“Freight Movement and Intermodal Access in Kentucky”  
Project No. SPR 98-189

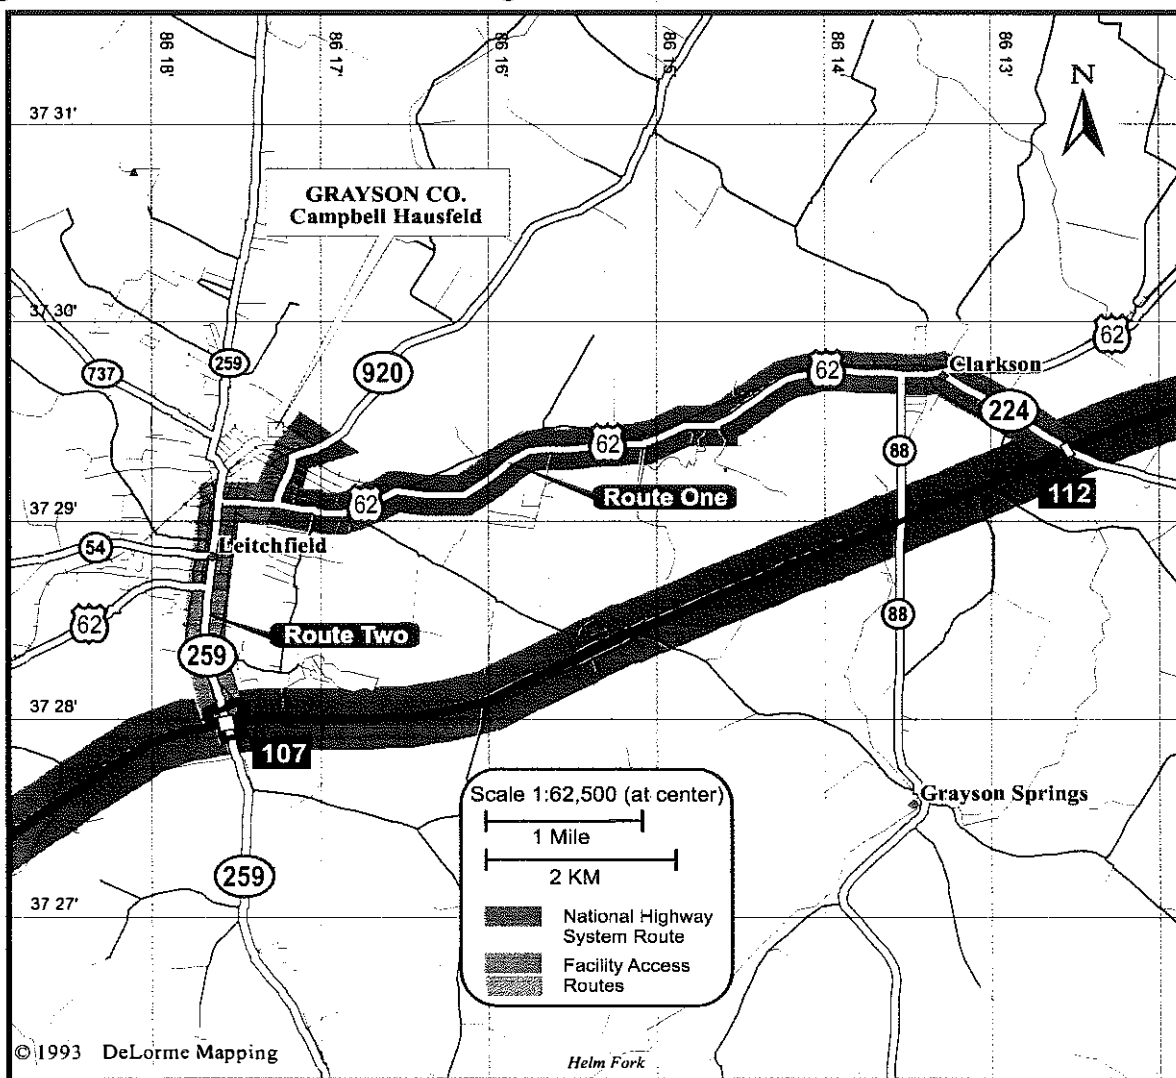
Figure 1: Location of Truck Generating Site

As shown in Figure 1, trucks use one of two routes to reach the NHS. Both routes follow Embry Drive to KY 920 and then follow KY 920 to US 62. The eastern route (shown in green) is used primarily by trucks traveling to Cincinnati. The route follows US 62 east to KY 224 which connects with the Western Kentucky Parkway and is approximately 5.1 miles in length. The western route (shown in orange) is used by trucks traveling west to Owensboro, and is approximately 2.1 miles in length. This route follows US 62 west through downtown Leitchfield and KY 259 to Exit 107 at the Western Kentucky Parkway. KY 920 passes through residential and urban areas near US 62 in Leitchfield. The US 62 east route passes through urban and rural areas. All roads except Embry Drive are state maintained. A detail map of Leitchfield is shown in Figure 2. There are two traffic signals along the eastern route and six along the western route. A route designation summary is shown in Table 1.

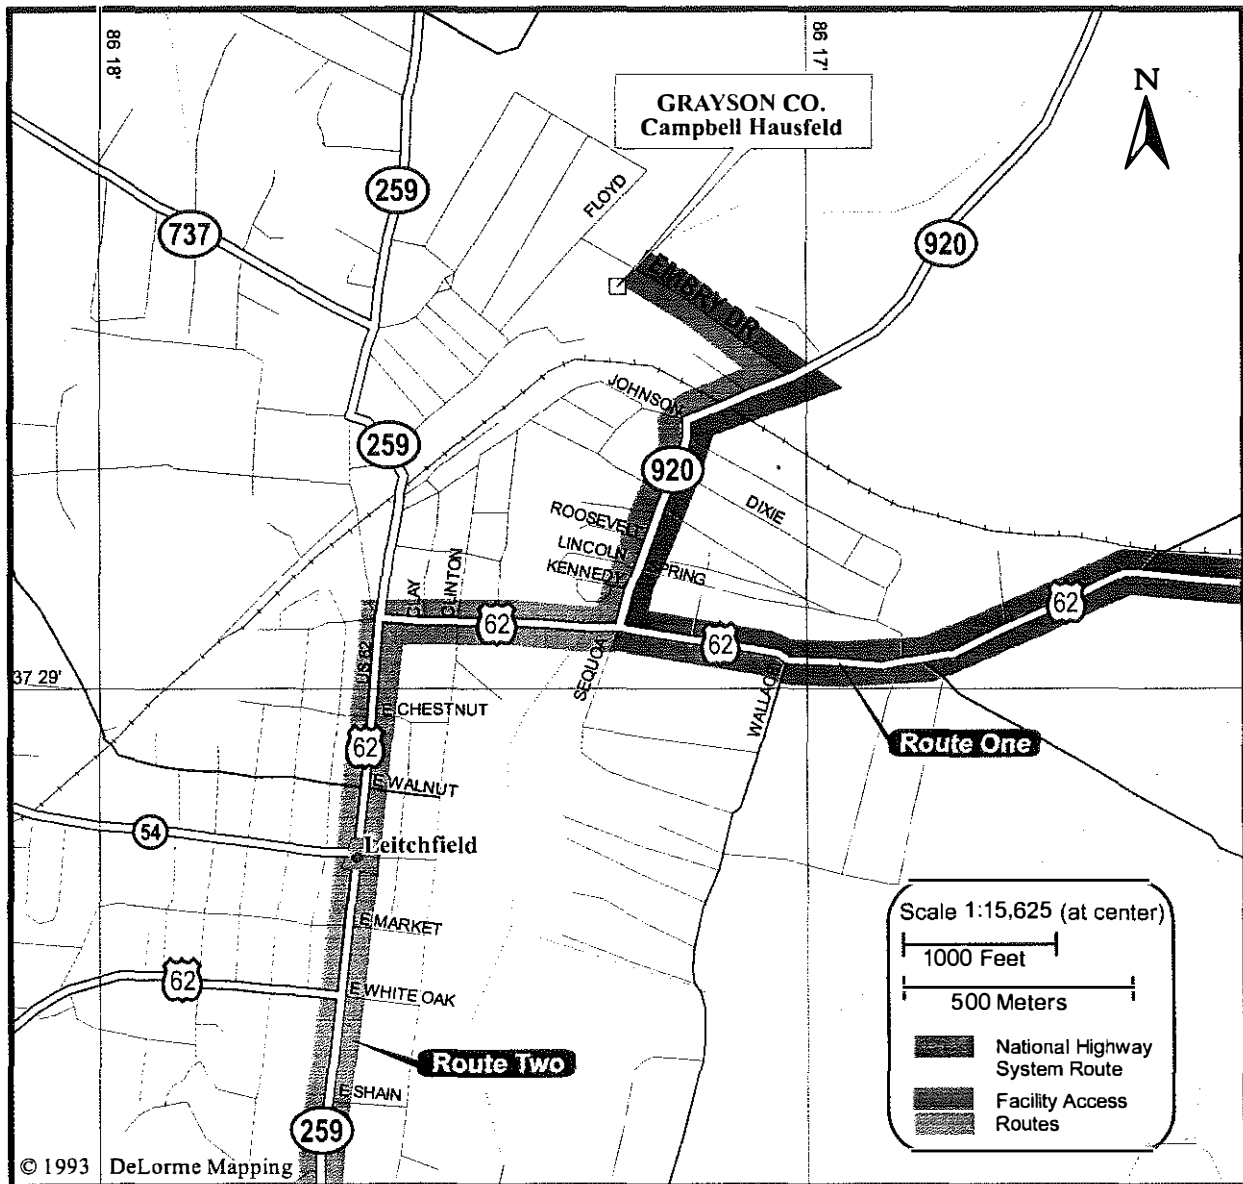
Figure 2: Detail Map of Routes in Leitchfield

There is one at-grade railroad crossing on the routes to this site. The crossing is on KY 920 near the intersection with Embry Drive as shown in Figure 2. The crossing has warning signs, flashing lights, gates and is relatively smooth giving it a “preferred” rating.

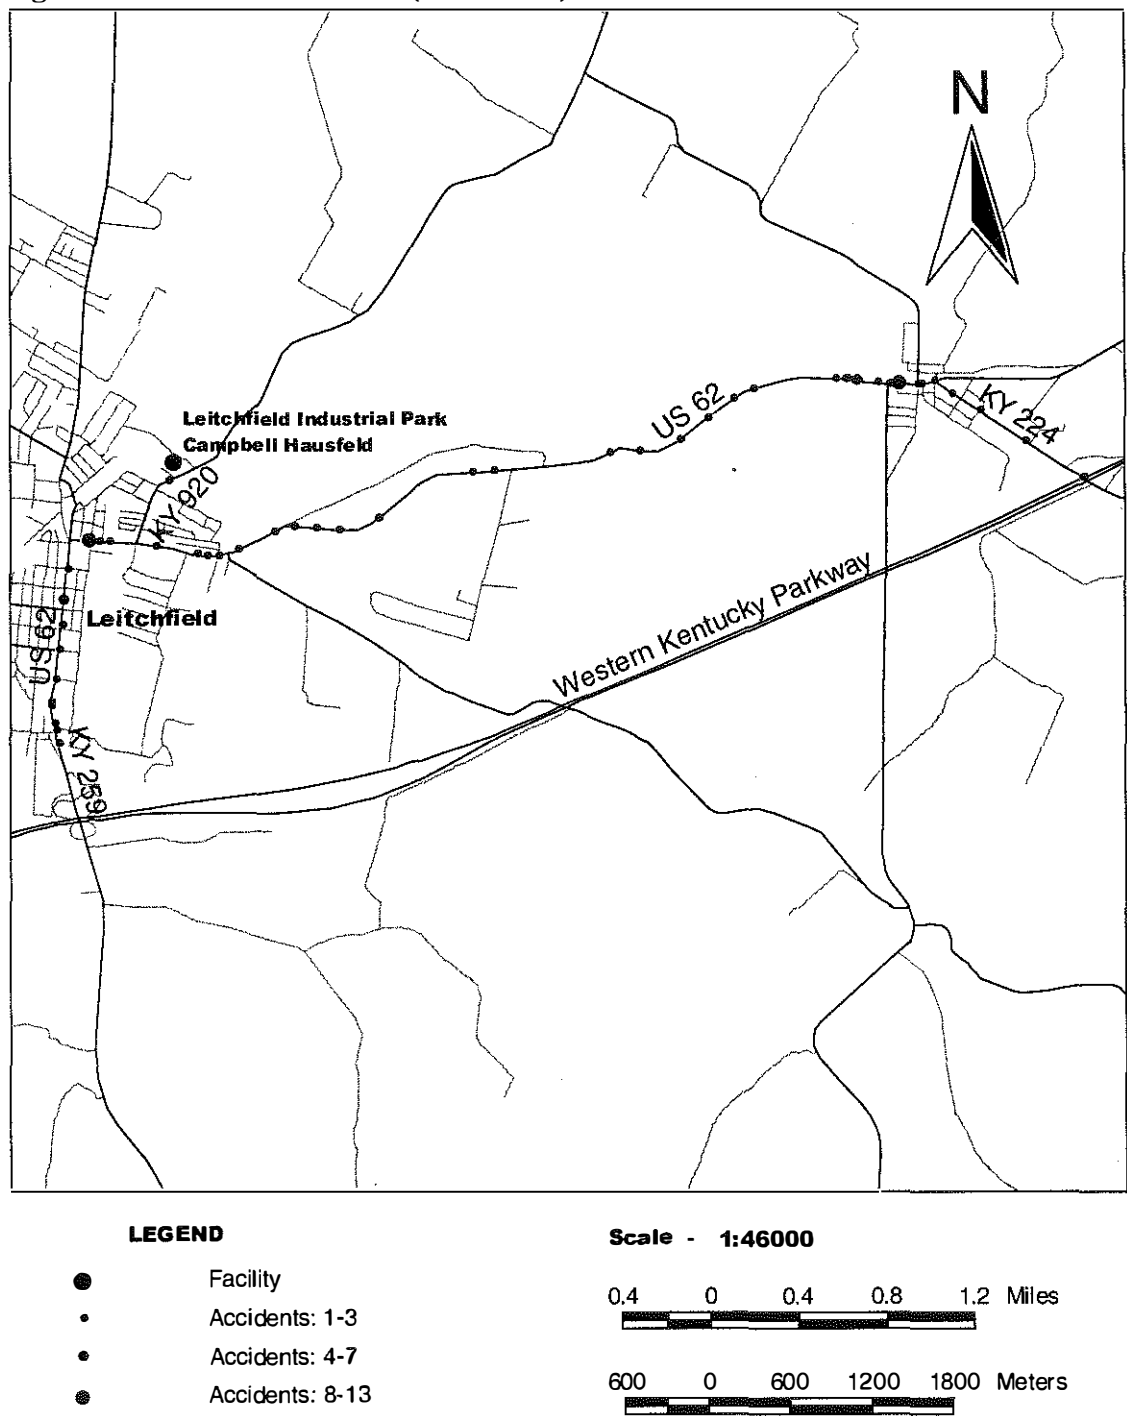
Figure 3: Accident Locations (1995-1997)

Figure 3 shows the locations of accidents during the years 1995, 1996 and 1997. The figure shows that the accidents were scattered along both routes with a significant number occurring in Leitchfield and Clarkson.

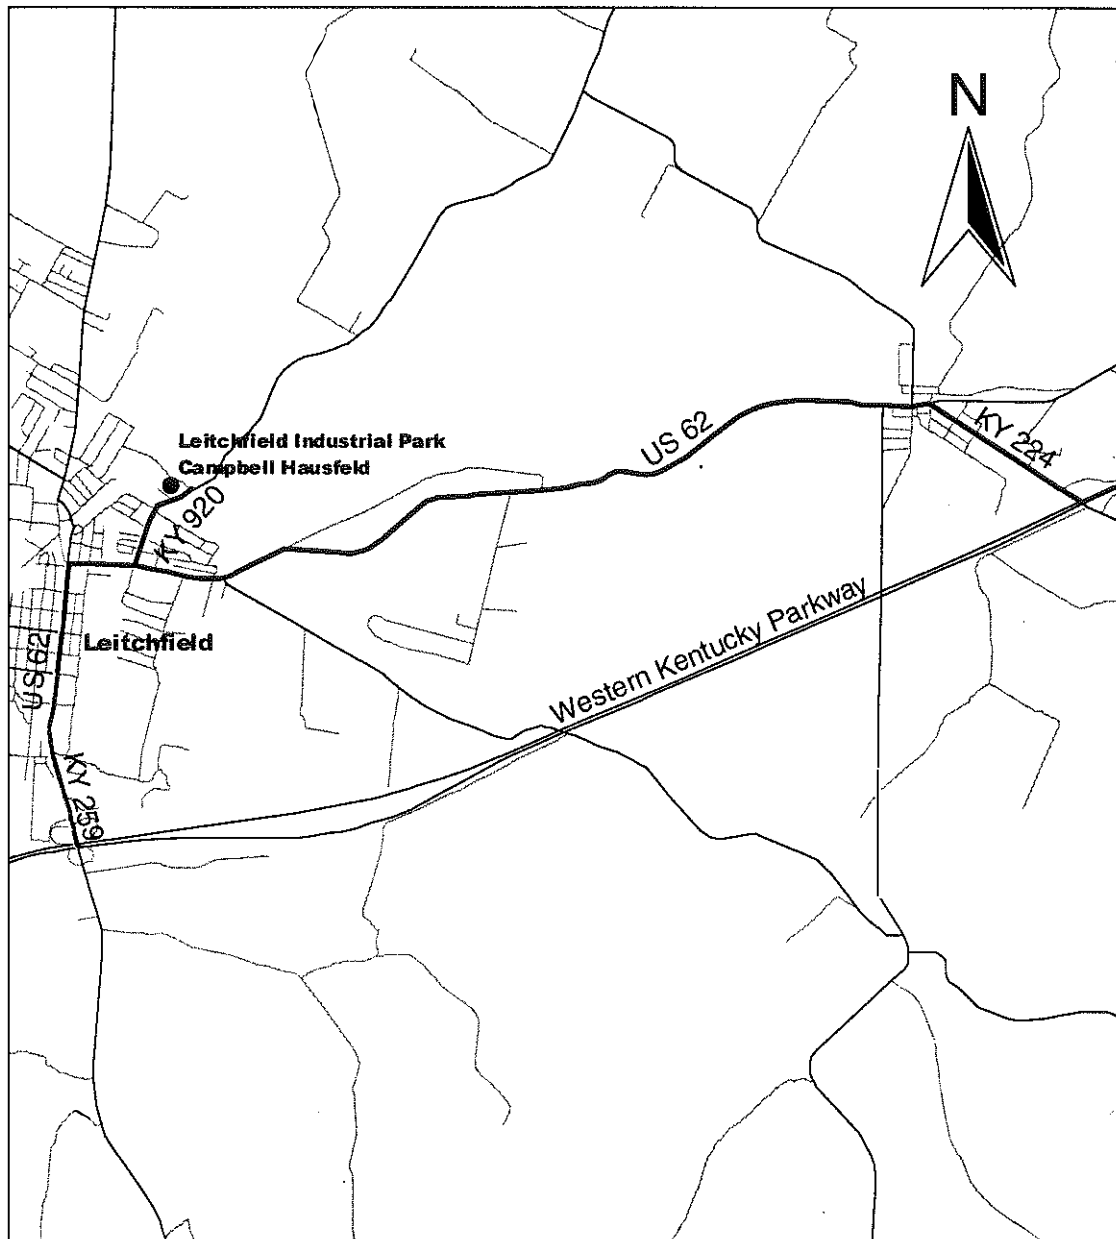
**Figure 4: Lane Widths**

Figures 4 and 5 illustrate the sections of the routes having different widths of lanes and shoulders. Along the eastern route, US 62 has “adequate” 11-foot lanes near KY 920 in Leitchfield and “less than adequate” 10-foot lanes in the rural areas. The “less than adequate” lane widths along KY 224 range from 9-10 feet. Along the western route, US 62 has “less than adequate” 10-foot lanes from KY 920 to the junction of KY 259. KY 259 has four “preferred” 12-foot lanes. There are no shoulders on Embry Drive or KY 920, while US 62 in Leitchfield is curbed. All other roadways have “less than adequate” two-foot shoulders. Ditches and side slopes cause clear zone problems along most of the routes. The pavement was generally good on most of US 62, KY 224 and KY 259, while it was in fair condition on KY 920 and Embry Drive.

The recommended improvement is the reconstruction of the intersection of KY 920 and Embry Drive to eliminate turning radius problem. Other roadways with lane and shoulder width problems could be addressed by rebuilding those sections of highways.

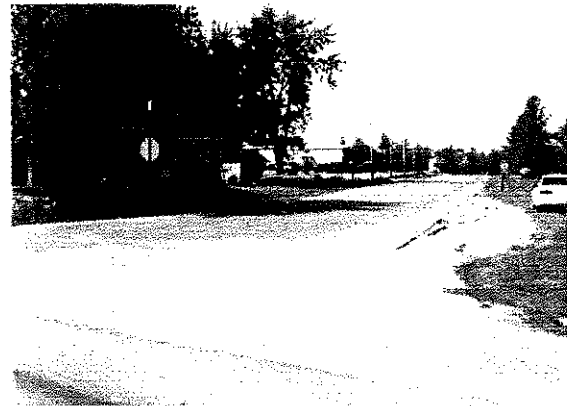
The turning radii at the intersection of KY 920 and Embry Drive was observed to be “less than adequate” as shown in Figures 6, 7, and 8. Several vehicles were observed encroaching into the opposing lane while making a right turn from Embry Drive onto KY 920. When making left turns into the industrial park from KY 920, vehicles also drove off the pavement either on KY 920 or Embry Drive. The approximate layout of this intersection is shown in Figure 9. The near 45° angle at which Embry Drive joins KY 920, along with the pavement width, increases the required turning radius. The original pavement intersected KY 920 without any widening. The turn from KY 920 onto Embry Drive, which is approximately 45°, was rated “less than adequate” because trucks drive off the pavement to make the turns, as shown in Figures 6, 7 and 8.

**Figure 7: KY 920 at Embry Drive**

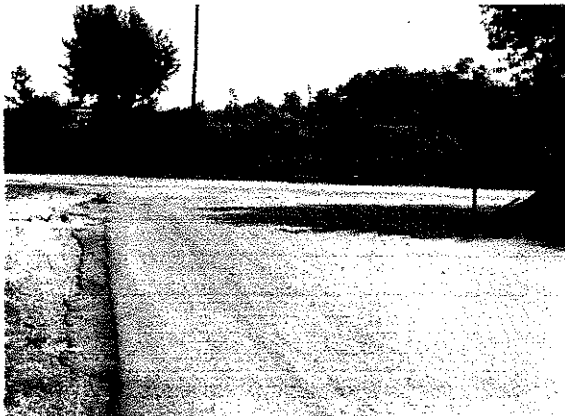
**Figure 8: Embry Drive at KY 920**

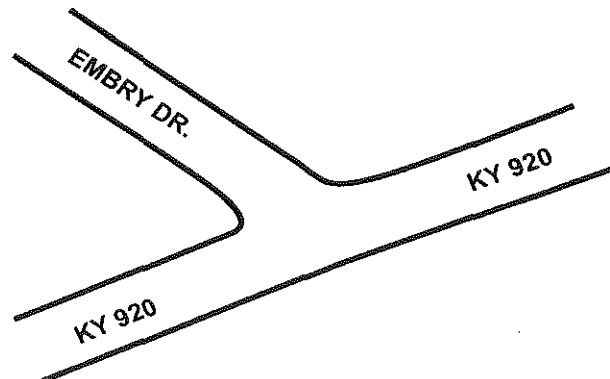
**Figure 9: Intersection Layout of KY 920 and Embry Drive**

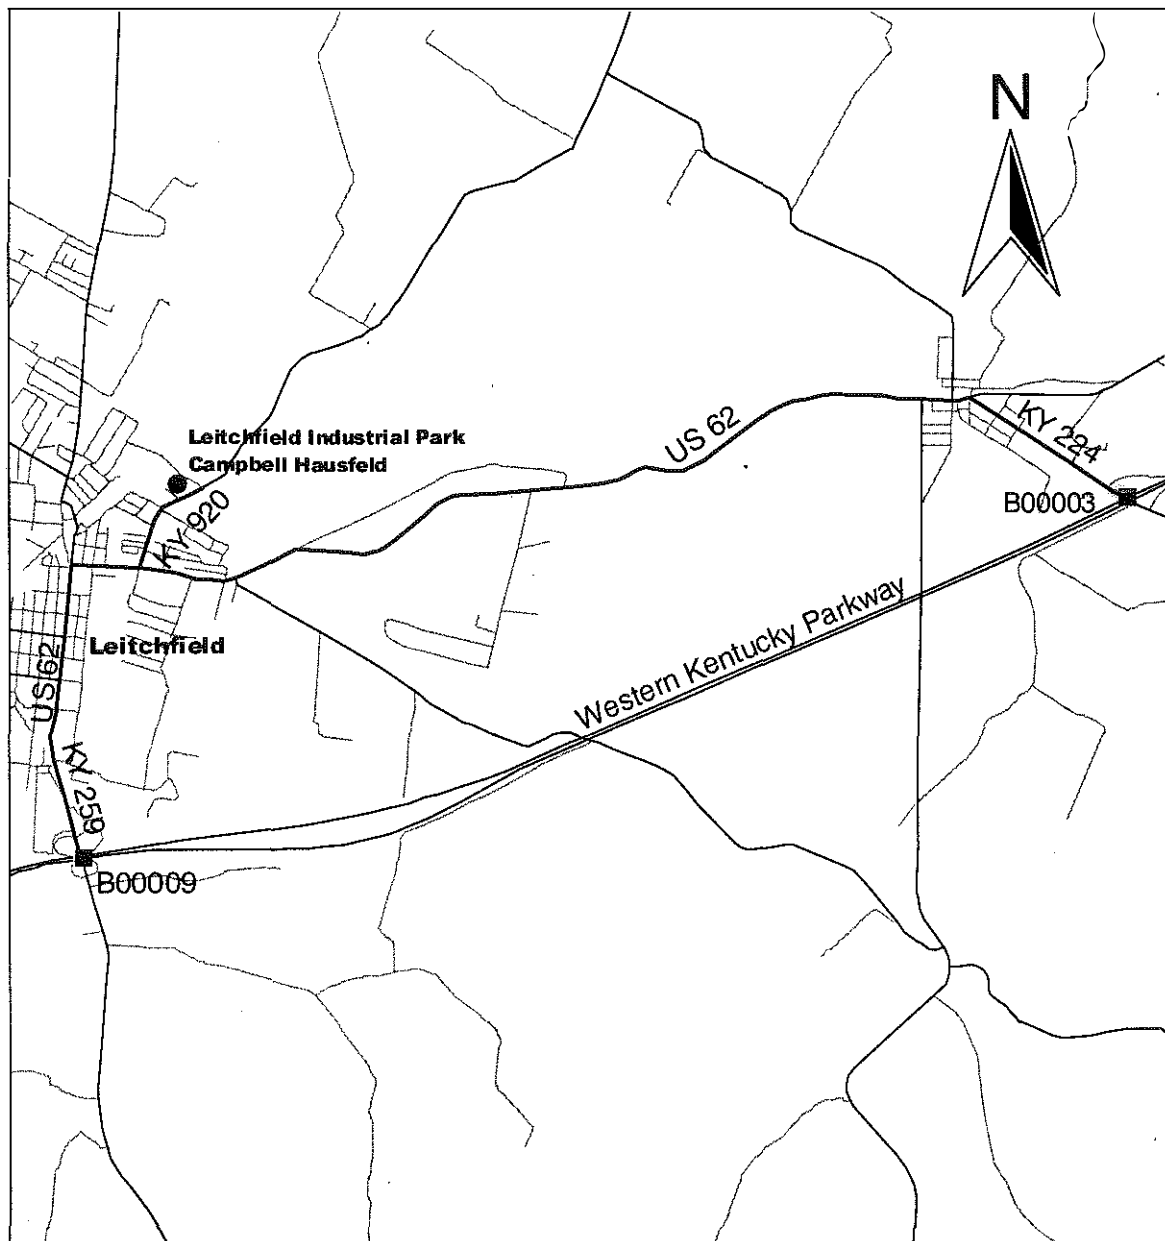
**Figure 10: Bridge Locations**

Figure 10 shows the location of the two bridges on these routes. The bridges are located at the points where the access routes intersect with Western Kentucky Parkway. The Kentucky Transportation Cabinet’s Division of Operations maintains a database of bridge sufficiency ratings that are based on the serviceability (as well as other factors) of the structure. The bridge along the eastern route on KY 224 over the Western Kentucky Parkway has a sufficiency rating of 75.2 giving it an “adequate” rating. The bridge on KY 259 over the Western Kentucky Parkway has a sufficiency rating of 66.8 which is also “adequate” for this study. A sufficiency rating of 80 or higher (out of a possible 100) is considered “preferred,” and a rating of at least 50 is “adequate.”
